Tank AY-102 Status

August 20, 2012

Summary

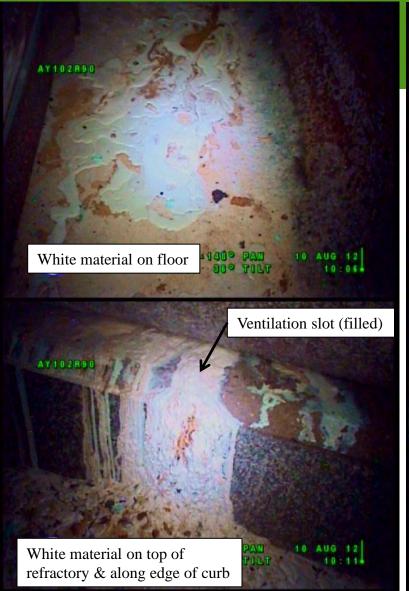
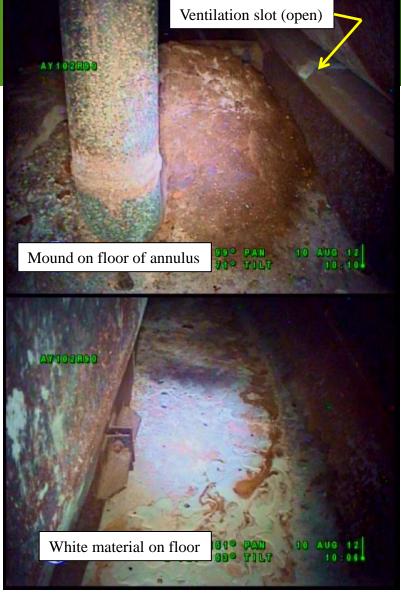
Riser 90 Inspection Photographs

Routine periodic visual monitoring (via camera) of the AY-102 annulus found material that was never before seen. Inspection of the annulus noted the following;

- Material found in two locations near Riser 90 source unknown
 - mound approximately (2 ft. x 3 ft. x 8 inches)
 - white material on both the refractory (tank sits on refractory) and annulus floor
- Material is dry (i.e., no standing water or indications of moisture)
- Leak Detection and Constant Air Monitor (CAM) Operable in Annulus (real time monitoring)
- Camera equipment removed from annulus without incident (i.e., no contamination on equipment)
- Contamination present when annulus floor sample was taken
